# Pre-Ignition & Detonation

*The information (and harrowing pictures!) in this article are reprinted courtesy of the FAA.*

Pre-ignition. Detonation. Both can be deadly. But what's the difference? And how can you avoid them?

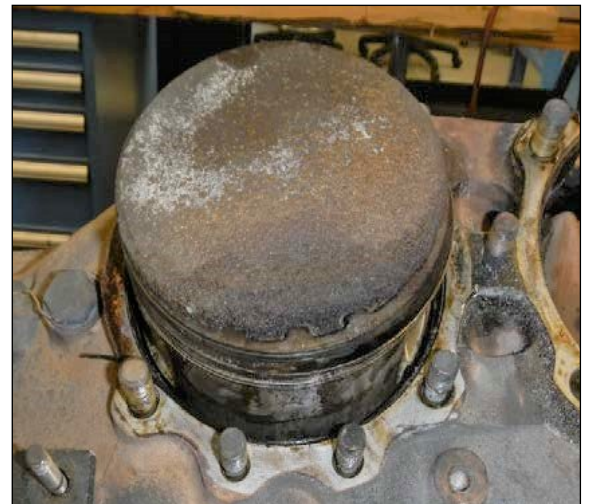
This engine is from a Beech S35 Bonanza's fatal accident. The #6 piston was eroded and began to melt. The rings and piston skirt were compromised by thermal expansion and metal transfer. Note the deep pitting and erosion of the piston face. This caused combustion gases to bleed into and over-pressurized the crankcase, forcing engine oil out the breather. The connecting rods then failed due to the lack of lubrication and smashed holes in the crank case, causing loss of power and engine failure.

**Piston pitting and erosion of the piston face**

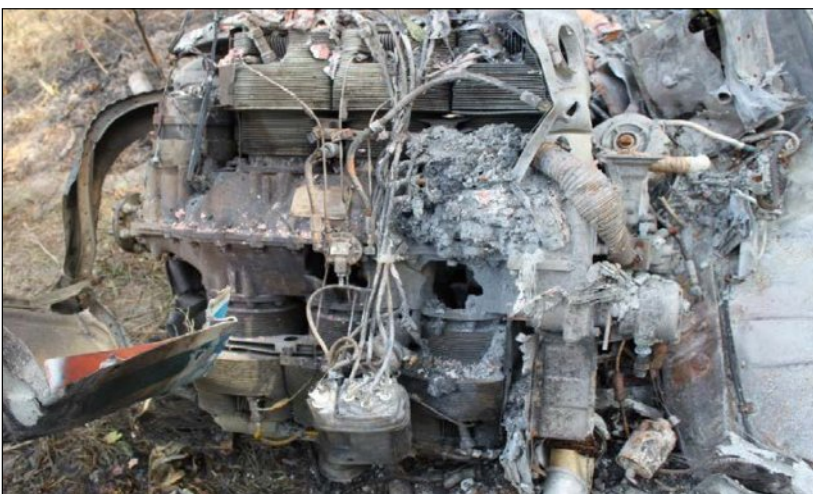
**Bonanza end result**

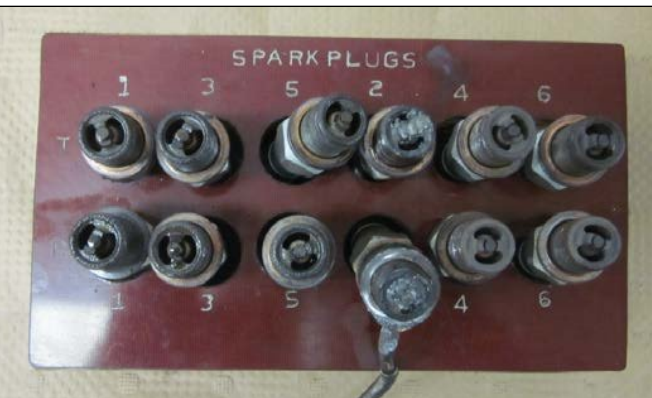
**These cylinder #2 spark plugs are packed with melted piston material.**

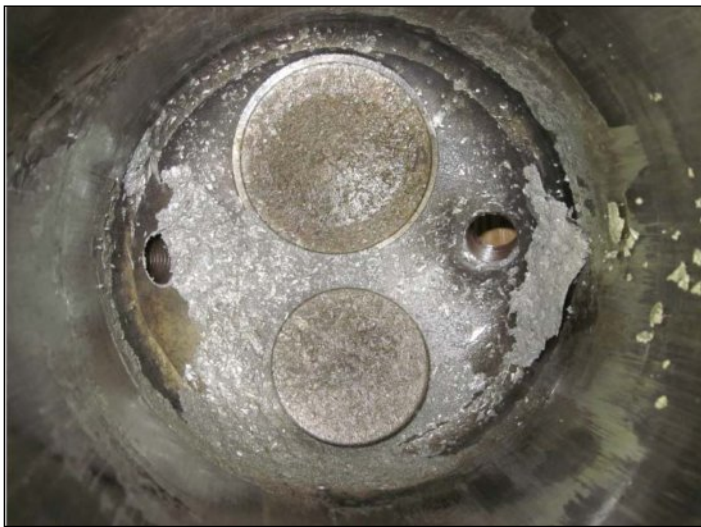
The picture to the left above is a cylinder head showing signs of pre-ignition or detonation. The carbon coating that normally lines the head dome is knocked off. There is melted piston material in the head and the cylinder sleeve is scored by the overheated piston.

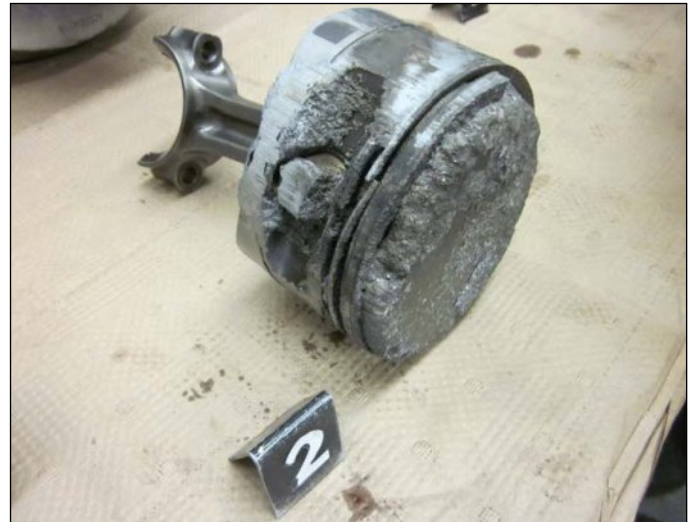
Above and to the right is the same piston. Note that the piston deck is eroded. The rings are broken. The piston skirt is scuffed from rubbing on the cylinder wall. A piston in this condition allows combustion gases into the crank case. This over-pressurizes the crankcase and blows engine oil out of the crank case breather -- all of the engine oil, in minutes.

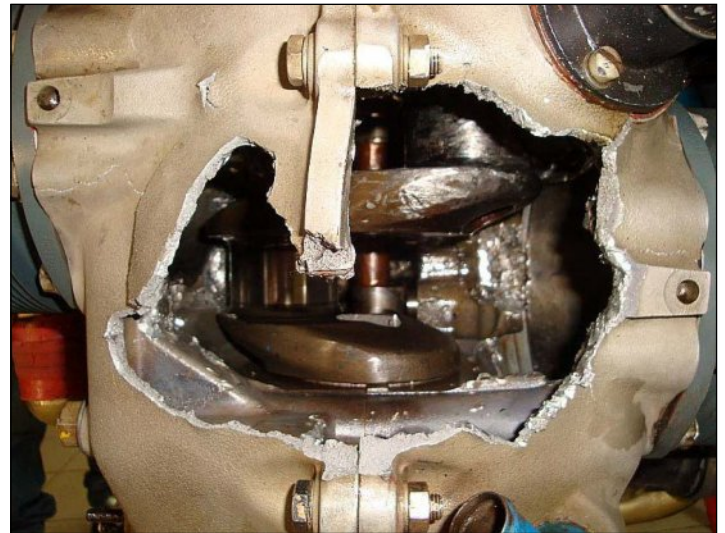
Soon after the engine oil departs the connecting rods try to make a break for it, resulting in giant holes in the crank case - see the image to the right.
